## TECHNICAL SERVICE BULLETIN

### Poor Air Conditioning (A/C) Performance - Evaporator Can Now Be Serviced Separately From The Climate Control Housing

**18-2256**

<b>Ford</b> 2015-2017 Mustang
----------------------------------

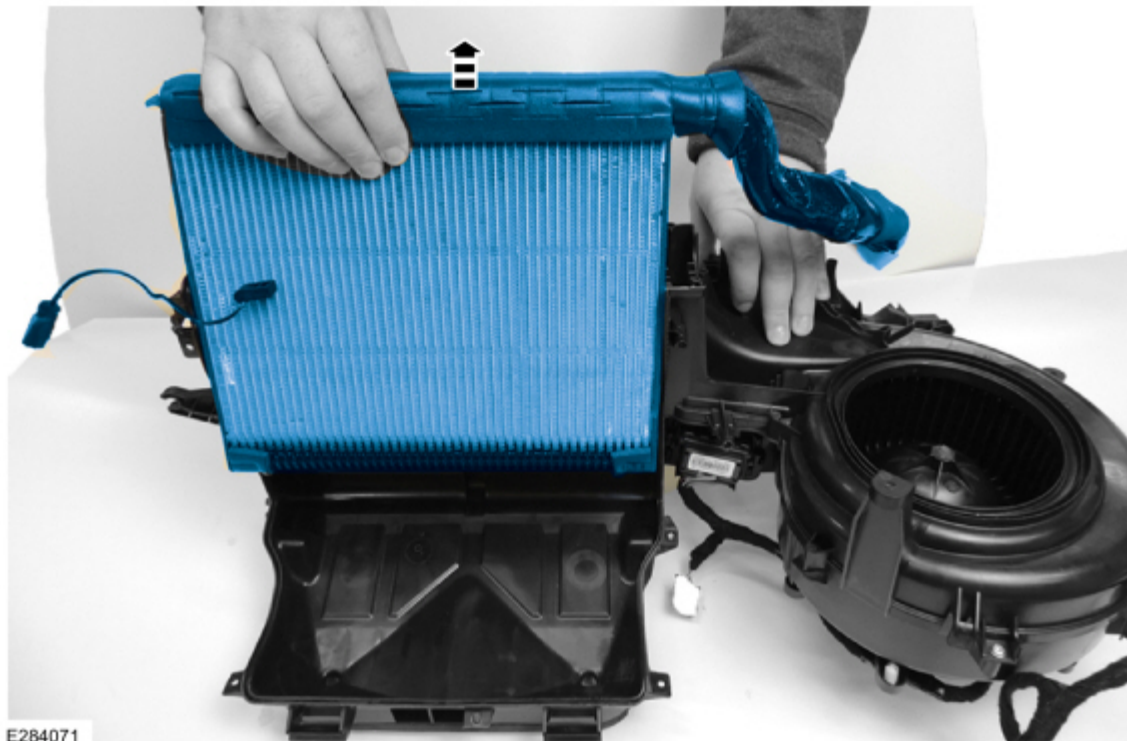
Figure 15

**Issue:** Some 2015-2017 Mustang vehicles may exhibit poor A/C performance. If the cause of this is found to be a refrigerant leak from the evaporator, it is recommended to replace only the evaporator as opposed to the entire climate control housing.

**16.** Remove the evaporator core from the climate control housing. (Figure 15)
